Magellan/Galileo Solder Joint Failure Analysis and Recommendations

Ronald G. Ross, Jr.

September 15, 1989

Jet Propulsion Laboratory
California Institute of Technology
Pasadena, California

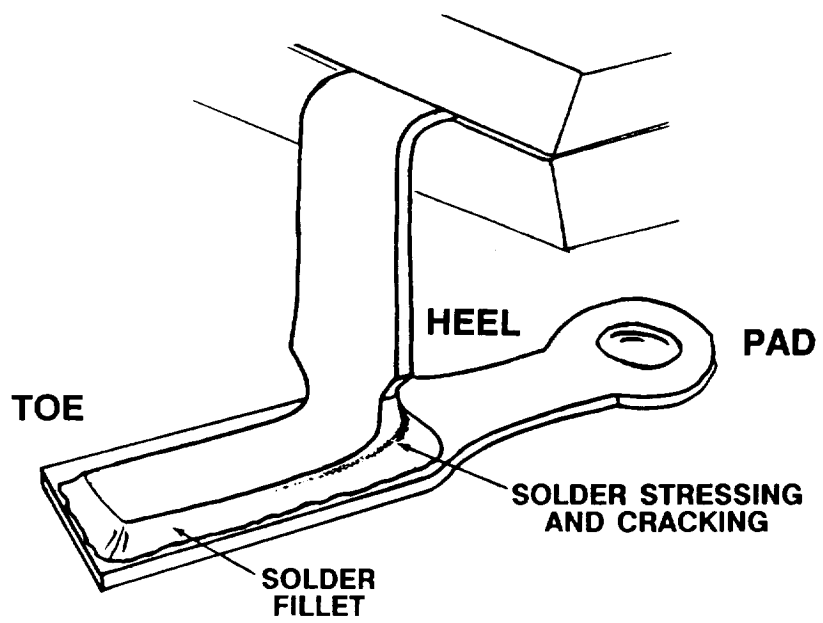
Fig. 7. Solder joint nomenclature

The observed cracks and stressing, schematically illustrated in Fig. 7, invariably initiated at the heel of the solder joints, and gradually progressed toward the toes. There was a general trend for all, or most of the leads on one side of the DIP, to be significantly worse off than those on the other side, and no particular trend for end leads to be worse than middle leads, or vice versa. It is hypothesized that one weakest lead fails first thus transferring mechanical loads it was carrying to its nearest neighbors, and thereby cascading into an unzipping action for all the leads on a single side. Once the leads on one side (eg. pins 1 through 8) yield, the leads on the other side (pins 9 through 16) will be relieved of their load and will remain in good condition.

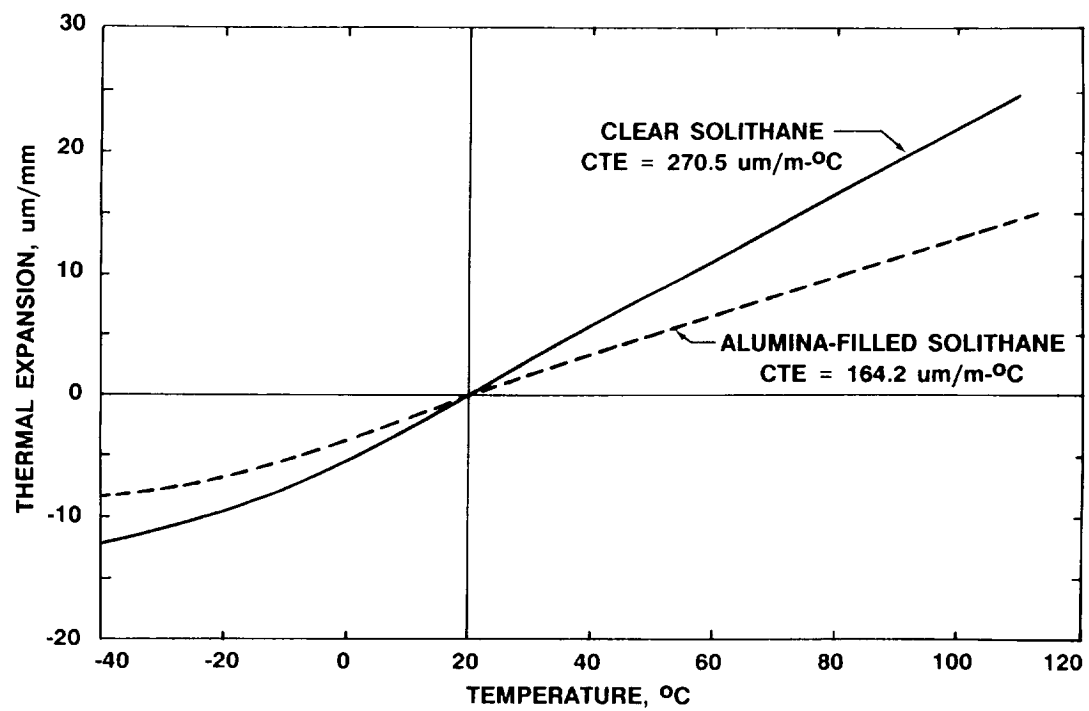
Fig. 9. Thermal expansion versus temperature for clear and alumina-filled Solithane

Clear Solithane (Beneath DIP) - As shown in Fig. 8, very severe stressing occurs when the large (0.055") gap beneath the DIP is completely filled with clear Solithane. Although the critical parameter is the very high coefficient of thermal expansion (CTE) of the Solithane (Fig. 9), the problem is further aggravated by the confining geometry of the gap beneath the DIP. This confined-space geometry prevents the lateral expansion of the Solithane and encourages it to grow vertically proportional to its volume expansion coefficient--this is three times the linear CTE. Further compounding the problem, there is some indication that the high-stress condition is aggravated by elevated-temperature (140°F) curing of the Solithane, as opposed to room-temperature curing. Also, vacuum application during curing tends to draw Solithane into the gap; however, the vacuum is not implicated as having any other effect, good or bad. **The high level of stressing observed with this conformal coat application requires that more detailed procedures be developed to insure that confined spaces (such as the space under DIPs) not be filled with Solithane during the conformal coating operation; simultaneously the procedures must assure that complete coverage is achieved of the active circuit elements under the part.**

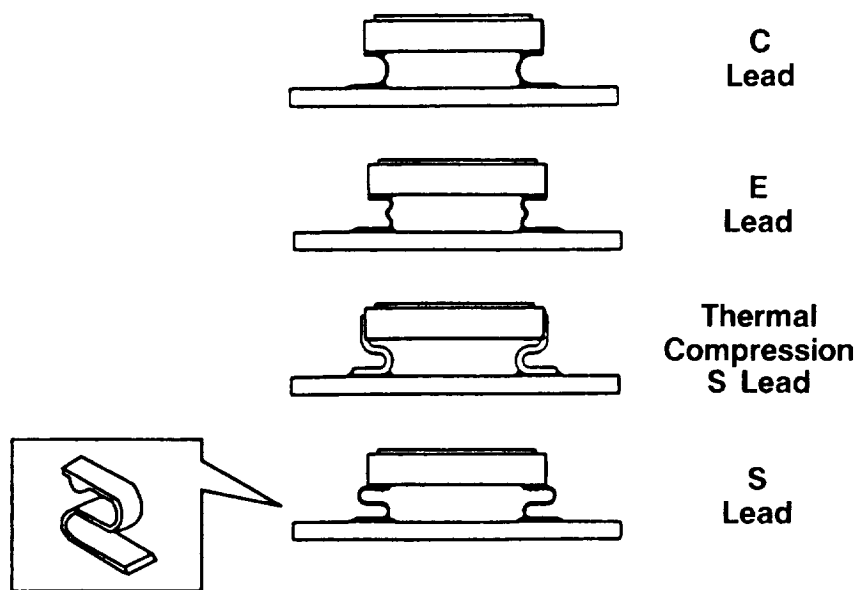
Fig. 16. Candidate strain relief modifications for DIP packages

Add mechanical flexibility in the component leads so that vertical motion due to applied loads is accommodated as strain in the leads, not in the solder joint - This alternative has been explored by many other organizations--examples of typical strain relief configurations are illustrated in Fig. 16. This technique has a proven success record, but requires extensive modification of the as-delivered DIPs. Dead-bug mounting also falls into this general category. For high-heat-transfer applications, the flexible leads must be combined with a high thermal conductivity heat-sink material.

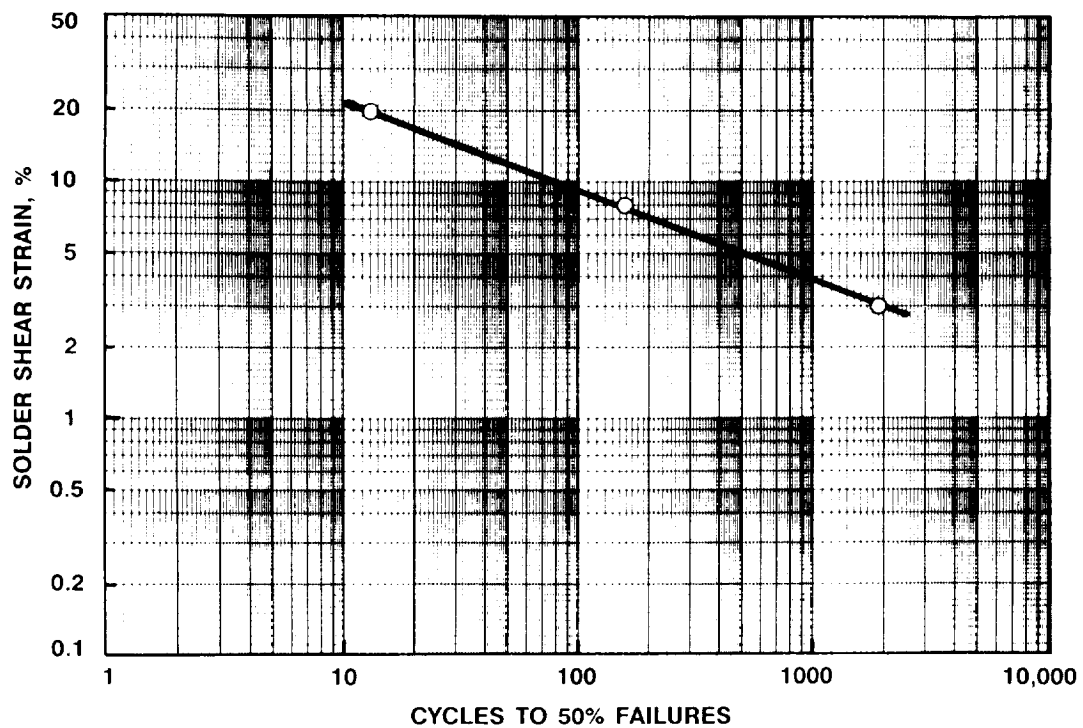
Fig. 18. Solder-joint fatigue life versus cyclic strain level at 25°C (IBM data using 15 minutes per strain cycle [8])

Figure 18 presents representative fatigue-life data for 63-37 SnPb solder joints taken from IBM test results [8]. The plot illustrates the typical dependency between cycles-to-failure and the level of mechanical strain introduced into the solder joint. Such a mechanism is called an accrued damage mechanism because failure occurs after a number of strain cycles have been accumulated. Note that the level of damage (number of cycles to failure) is an extremely strong function of the strain level. Doubling the strain (for example doubling the Solithane thickness) can reduce the fatigue life by nearly an order of magnitude.

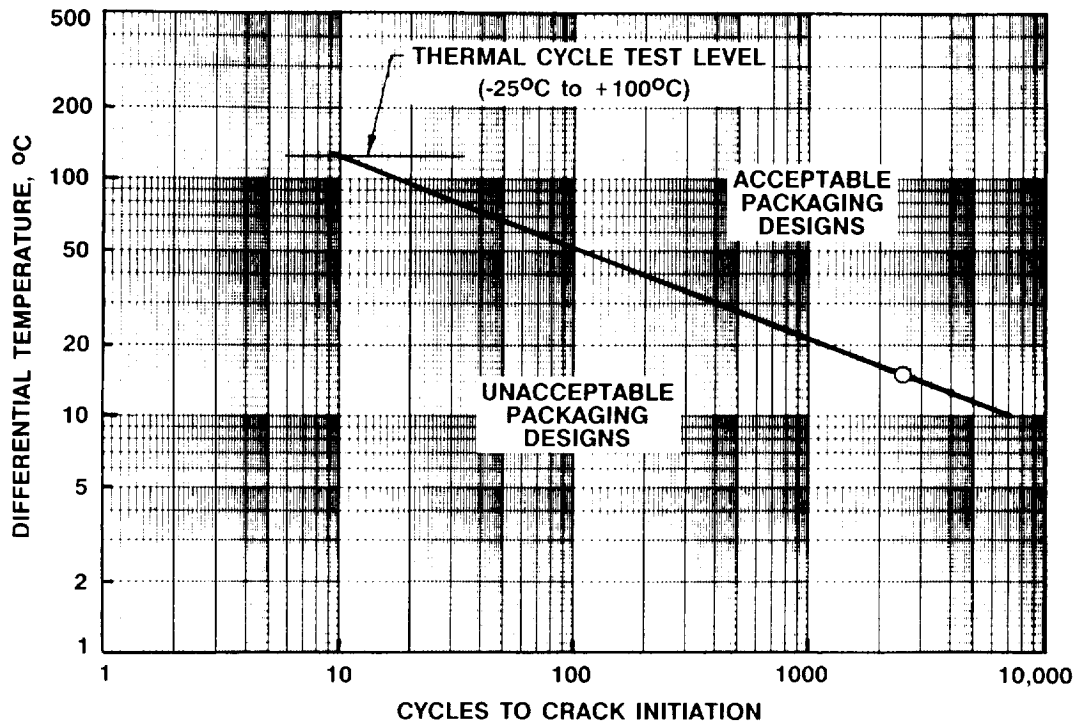
Fig. 20. Example solder-joint thermal-cycle fatigue-life requirement for a spacecraft electronic package

When establishing the level of fatigue endurance of an electronic packaging concept it is most economic to use a thermal-cycle test with a relatively deep cycle; this minimizes the number of cycles that must be run. For example, the thermal cycle requirement in Fig. 20 is equivalent to 10 cycles with a depth of 125°C--this is easily implemented by cycling between -25°C and +100°C, thus avoiding both unrealistic environments significantly below the Solithane glass-transition temperature at -15°C, and elevated temperatures above 100°C, where solder strength decreases precipitously.

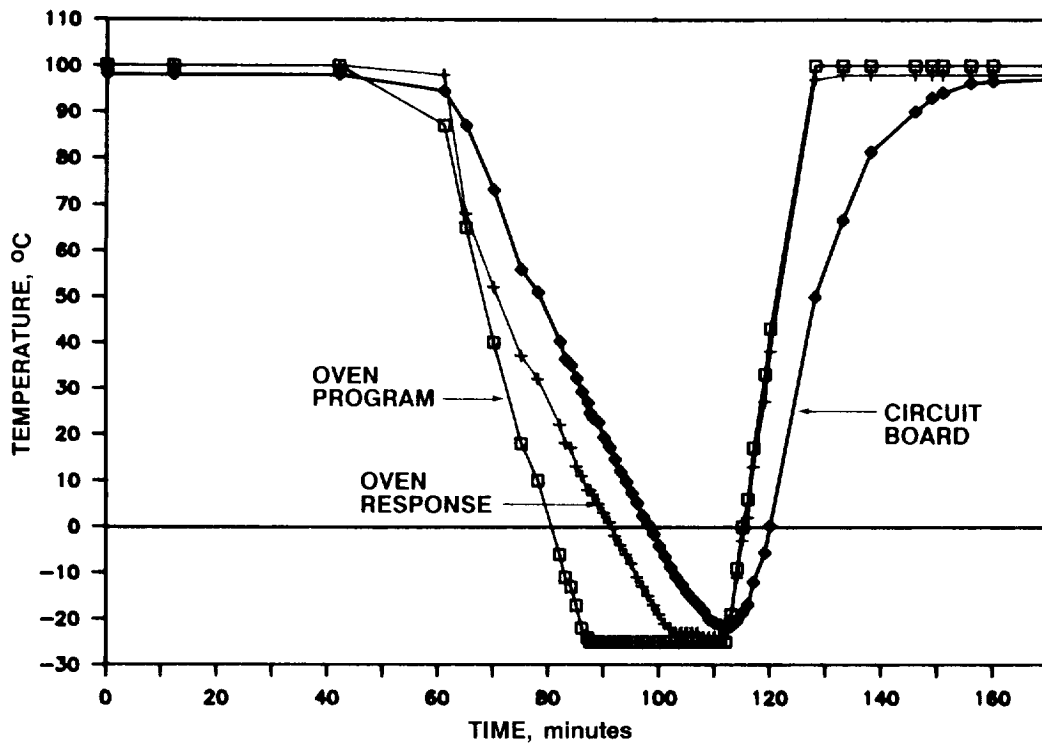
Fig. 21. Thermal cycle used to characterize and qualify Magellan and Galileo solder-joint fixes

Such a cycle, shown in Fig. 21, was used extensively during this Tiger-Team effort to quantify the fatigue resistance of the various packaging DIP mounting techniques contained in the flight hardware, as well as alternatives proposed as fixes. Note that the cycle shape contains a significant (2 hour) dwell at 100°C to accelerate creep-rupture failures, and turns around quickly at -25°C, where creep is negligible, to conserve test time. The ramp rate between extremes is chosen slow enough to negate thermal shock effects caused by excessive thermal gradients.

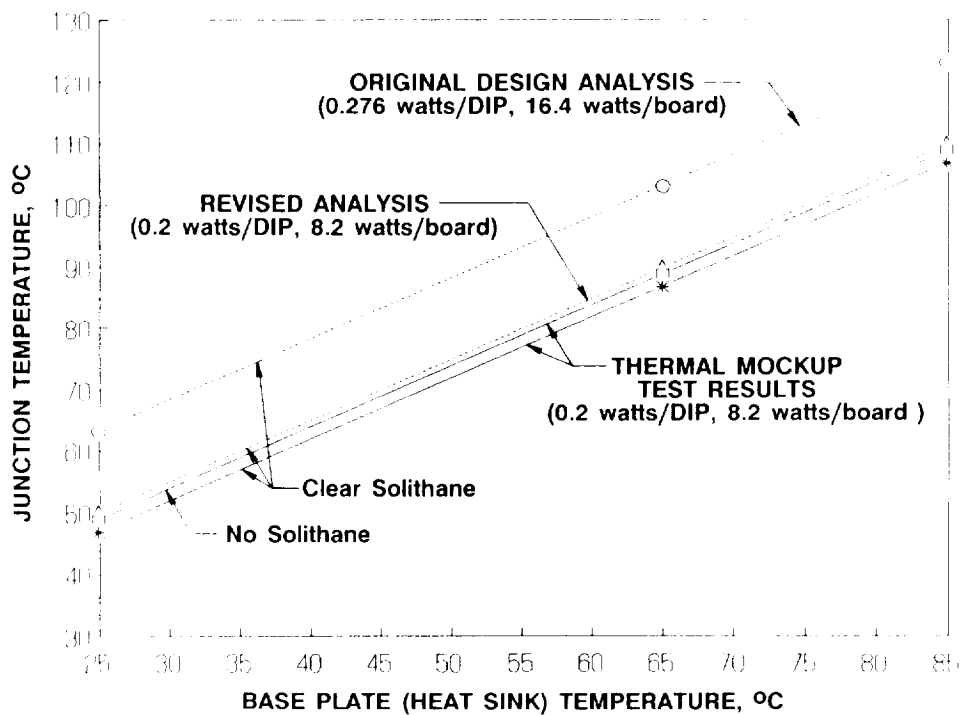
Fig. 24. Comparison of analysis and test data on DIP junction temperature in vacuum as a function of circuit board heat-sink temperature

Examination of Fig. 24 reveals that the rework design with no Solithane under the parts has excellent margin; the predicted junction temperature is only 55°C for the expected flight baseplate temperature of 30 to 35°C, and is below 70°C at the maximum allowable flight baseplate temperature of 45°C.

The test data also demonstrate that the presence of clear Solithane beneath these parts only lowers the part temperature by 2°C (3°C for alumina-filled Solithane). This temperature reduction would increase proportionately for parts with higher power dissipations, or for parts such as flat-packs, which have much greater thermal resistance in their leads.

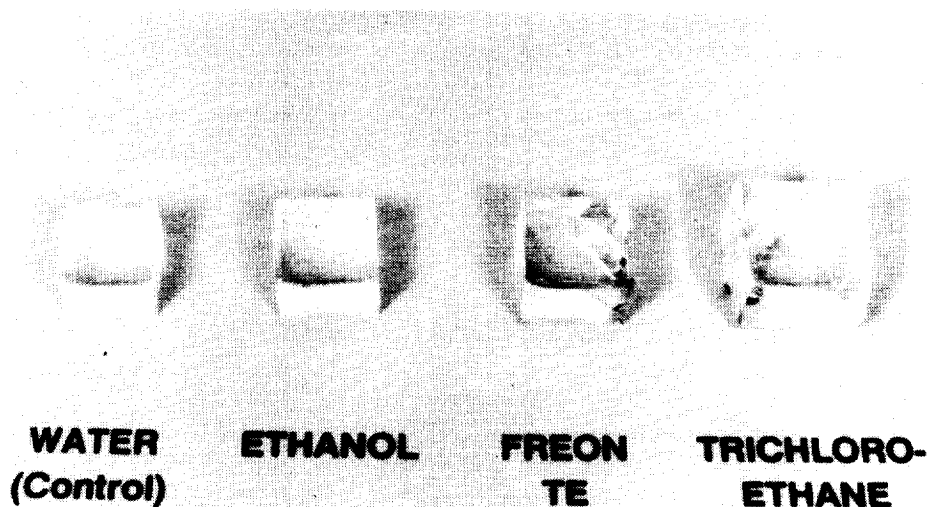
Fig. 25. Visual appearance of 5/8" clear Solithane cubes after immersion in solvents. Before solvent exposure, all cubes were identical in size to the cube labeled "control"--water immersion had no swelling action. After withdrawal from the solvent, the cubes return to their original size

It is clear from these experiments that Trichloroethane is extremely reactive with the Solithanes, and causes enormous swelling; under no circumstances should it be used in the presence of the Solithanes. Freon TE and Ethanol are much less reactive. Considering the fact that Freon

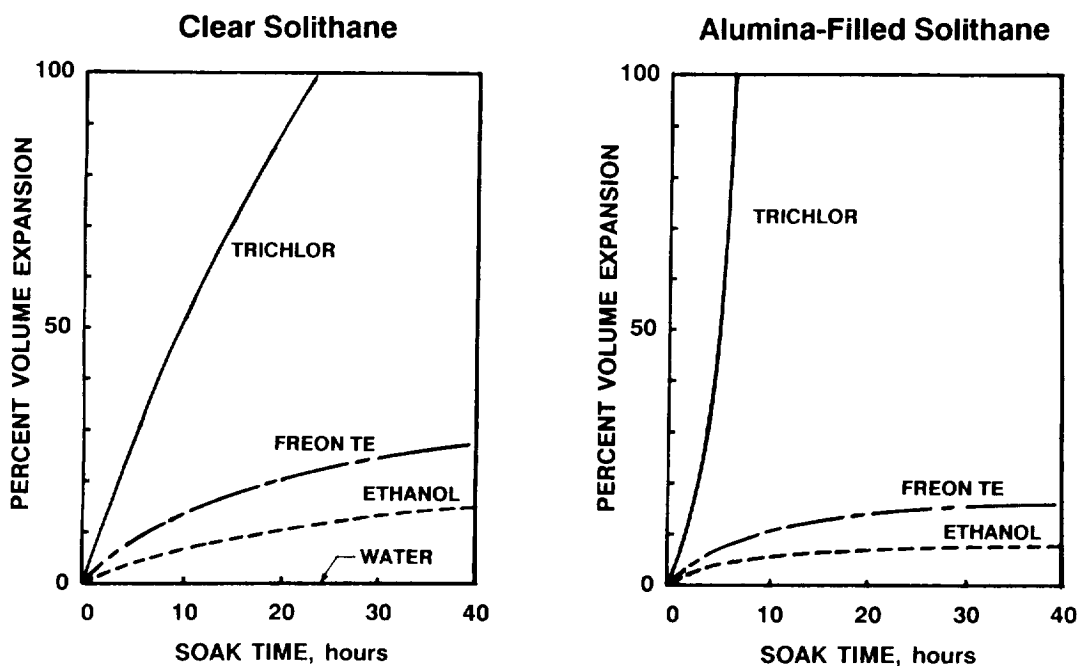
Fig. 26. Volume percent expansion of clear and alumina-filled Solithane (5/8" cubes) during immersion in solvents

Normally, cleaning solvents such as Trichloroethane, Freon and Alcohol are applied only prior to conformal coating. This precludes negative interactions between the solvents and the polymeric materials. Unfortunately, in the rework setting, cleaning solvents are often required to be used after the conformal coat or heat-sink compound is applied and cured in place. During rework cleaning, the solvent will be adsorbed by any contacted polymeric material and cause the polymer to swell. The amount of swelling is very dependent on which solvent is used, and the length of solvent exposure. Fig. 25 illustrates the dramatic swelling of 5/8" cubes of clear Solithane after reaching equilibrium during room temperature immersion in the noted solvents: water, Ethyl alcohol, Freon TE and 1,1,1-Trichloroethane; Figure 26 presents quantitative data for the same cubes. Note that the alumina-filled Solithane exhibits a much faster time constant than the clear Solithane (probably because of its foamy porosity), but reaches a lower equilibrium level of swelling due to the presence of the alumina filler.

As might be expected in light of their much shorter time constant for diffusion, thin sections of Solithane are found to expand much more rapidly than these bulk samples. For example, 0.030" thick samples of clear Solithane reached 30% volume expansion in Trichloroethane in 5 minutes, and 10% volume expansion in boiling Freon TE (43°C vapor degreaser) in 4 minutes [4].

evaporates much faster than Ethanol, its use should shorten the exposure period. Although brief (less than 5 minutes) exposure of Solithane to Freon TE and Alcohol is relatively benign, prolonged exposures to even these solvents can cause significant damage to parts with trapped Solithane, such as under DIPs and flat packs.
